DIE ERDE

Severe historical floods on the river Roda, Thuringia: from reconstruction to implications for flood management

Mathias Deutsch, Tobias Reeh, Daniel Karthe 2018: Severe historical floods on the river Roda, Thuringia: from reconstruction to implications for flood management. – DIE ERDE 149 (2-3): 64-75

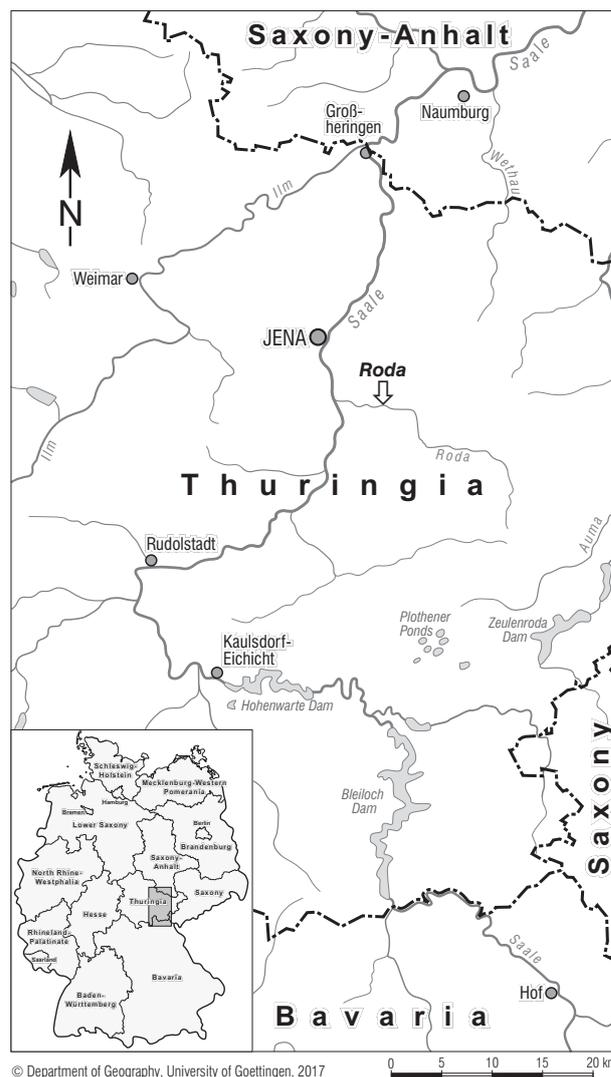
Fig. 1 Map of the Roda's course. Source: Own elaboration (Department of Geography, Georg-August-University Göttingen)

The Roda river is a right tributary of the Saale river and originates at an elevation of about 385 m a.s.l., not far from Triptis, a small town in the present-day Saale-Holzland-Kreis (Bauer 2013: 174). After about 33 kilometres, the Roda river flows into the Saale river at an elevation of 149.5 m a.s.l., close to Jena-Lobeda (Bauer 2013; Fig. 1). The catchment area is only about 262 km² (Bauer 2013), which means that it can be easily covered by a major thunderstorm cell. Such a constellation is quite typical for hazardous flood events in Thuringia. The percentage of the area covered by coniferous forests is 50%. 25% of the drainage basin is covered with farmland and 17% is grassland (Fischer 2008: 63). The annual precipitation within the drainage area is around 600 mm (Fischer 2008). Significant tributaries of the Roda river are the Schwarzbach, the Weiherbach and the Zeitzbach. During the 19th and 20th centuries, parts of the Roda river were modified by hydroengineering, including measures such as the fortification of the river's banks as well as the expansion and deepening of the stream profile (Photo 1). According to the *Deutsches Gewässerkundliches Jahrbuch* ("German Hydrological Yearbook") (Elbe region, part I), there have been several severe floodings of the Roda river after 1950 (LHW Sachsen-Anhalt 2012: 167). Among other floodings, those of 4 June 1961 and 10 August 1981 caused extensive inundations (Photo 2). Most recently, a flooding of the Roda river during the end of May/beginning of June 2013 caused severe damages and losses in agricultural and inhabited areas.

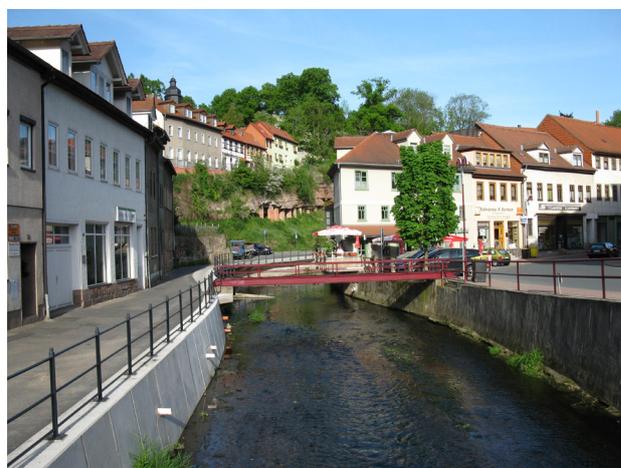
Photo 1 View over the Roda river which was modified in the centre of Stadtroda during the 19th and 20th centuries. Photo credit: M. Deutsch 2012

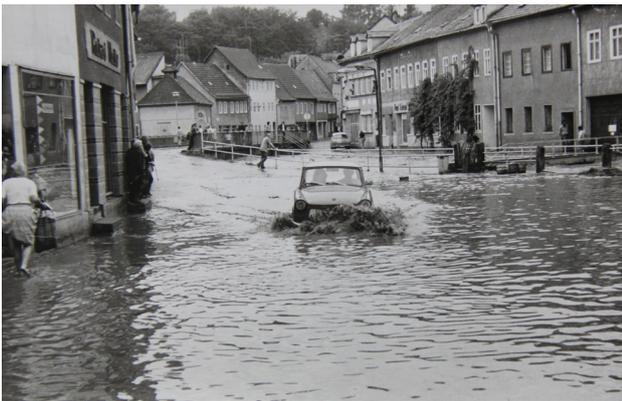
Photo 2 Flooding of 10 August 1981 in Stadtroda near Münzbrücke. Source: Anonymous 1981, Town archive Stadtroda, folder "Natural Hazards", no sign.

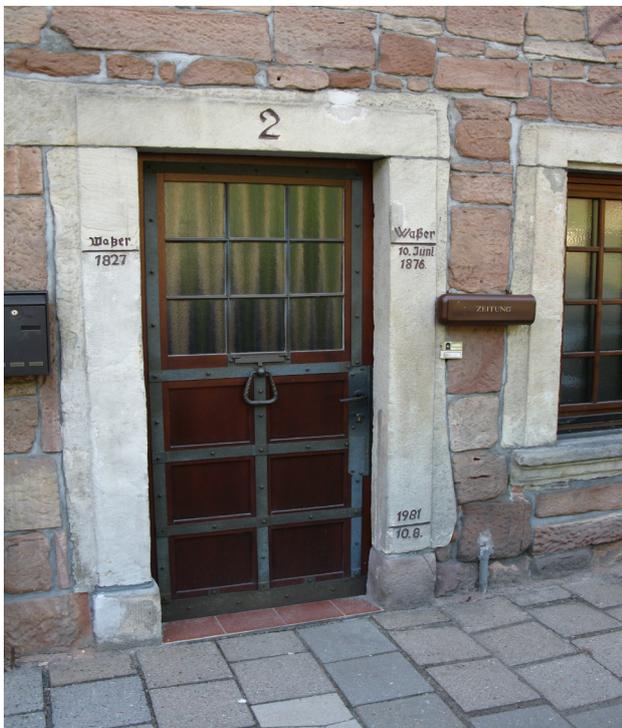
Photo 3 Flood marks in the entrance area of the residential building Am Sand 2 in Stadtroda. Photo credit: M. Deutsch 2014

In terms of flood marks (*Deutsch and Pörtge* 2009: 454), different material sources were preserved alongside the Roda river and its tributaries. In Stadtroda alone, two residential buildings and one former mill building provided flood marks which provided valuable information. The inscriptions impressively show the extremely high water levels of past floodings (*Photo 3*).
